HOUSTON, TEXAS

FLORIDA PANHANDLE

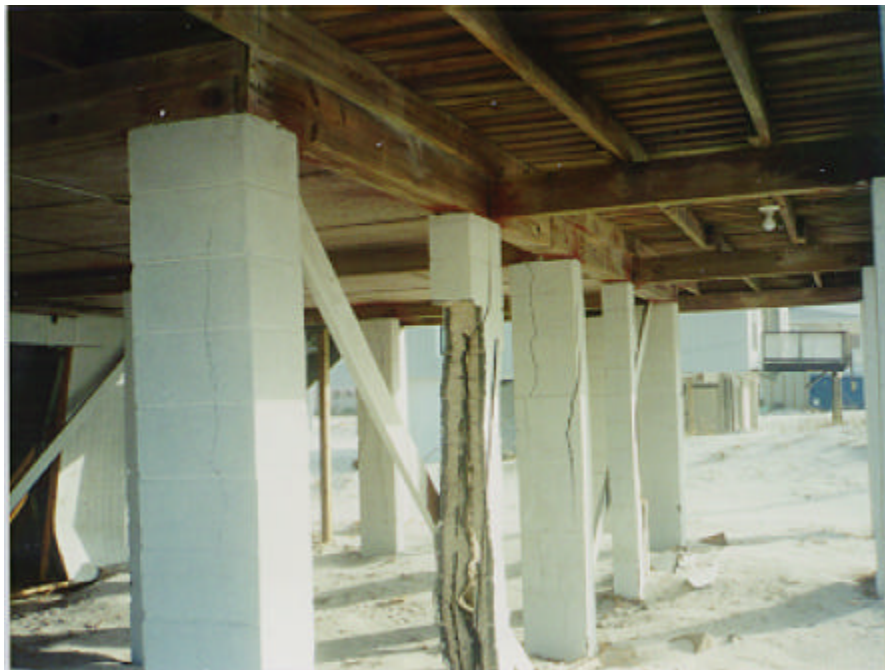
Looking at the column support that was nearing failure.

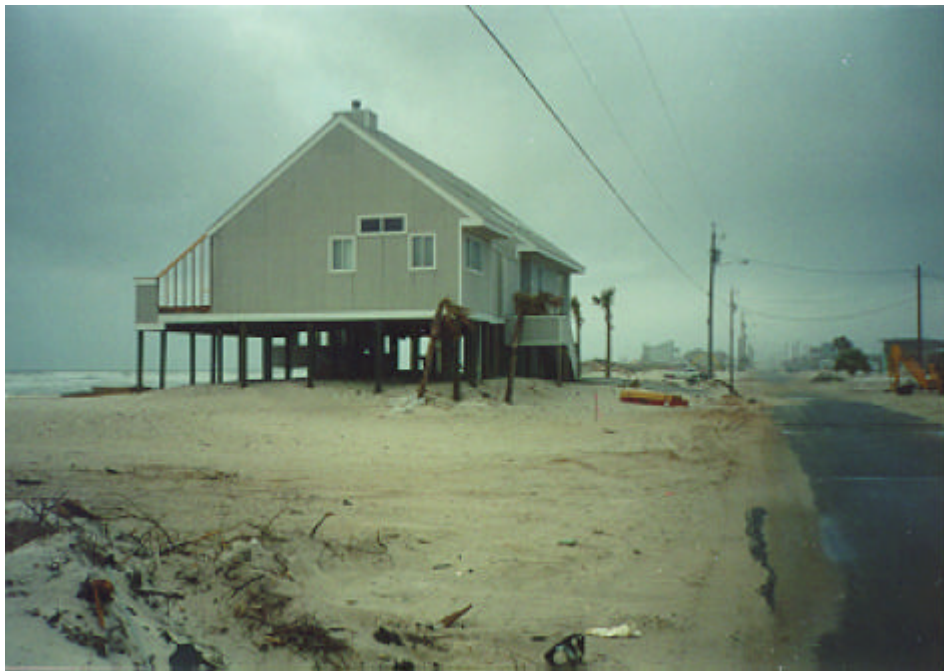
STRUCTURE 89. This structure was a new, one-story, single-family home elevated on wood piles. It directly fronted the beach. The structure employed proper elevation, wood piles for support, proper pile embedment depth, minimal floodwater obstruction, and proper wind proofing. The structure received minimal damage during the event. It was the only structure in the reach that survived.

Lesson. This structure survived the event well because it incorporated proper design and construction to withstand hurricane force winds, flooding, and hydrodynamic force associated with such a storm.

Looking at the structure. Note the beach at the left. Note also the absence of adjacent structures, which had been destroyed and removed.

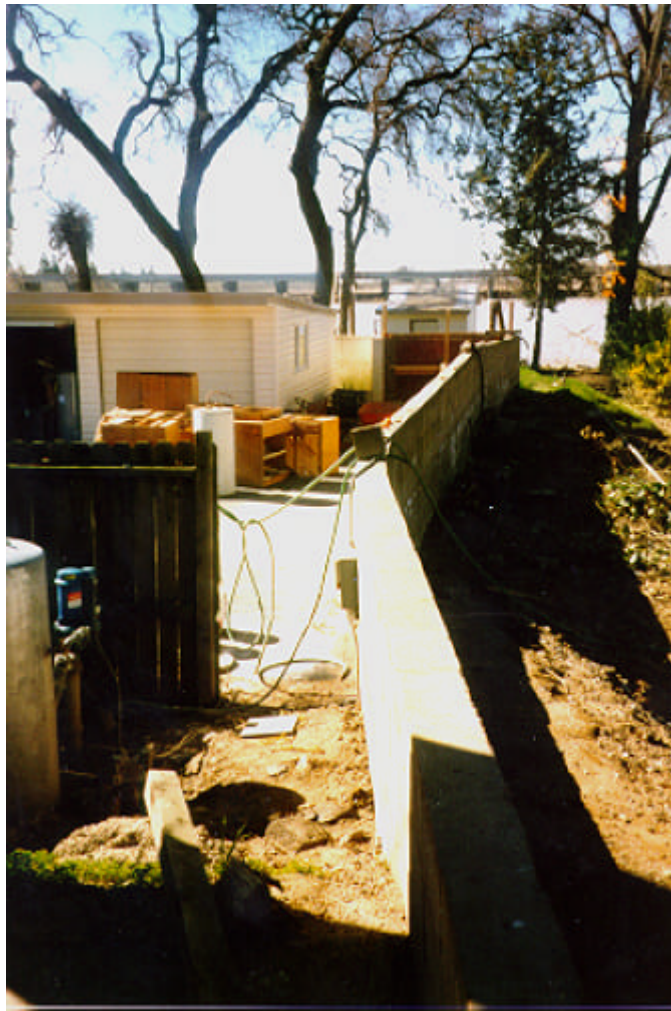
STRUCTURE 90. This structure was a one-story single-family residence with a slab-on-grade foundation. The structure was located about 70 feet from the Sacramento River between the river and a levee. It was oriented with its largest dimension parallel to the river. The Sacramento River at this location was above flood stage for about 2 weeks. There was ample warning time prior to the flooding. The structure was protected by a floodwall made of 100 percent grouted concrete block. Horizontal and vertical steel reinforcement was in the wall. The original wall was built prior to 1986. Subsequent to 1986, the wall was extended upward 26 inches with $\frac{3}{8}$ inch rebar located every 32 inches to tie the new wall to the old wall. The maximum height of the wall above ground was 64 inches. The minimum distance of the wall to the structure was 3 feet. The wall surrounds the structure on three sides. The wall tied into the levee, a “mainline” levee protecting the City of Sacramento, which provided protection on the fourth side. The floodwall had two openings in it on that portion paralleling the river. The openings were 3 feet and 8 feet wide. The 3-foot-wide opening was closed with a single piece of $\frac{5}{8}$ inch plywood attached by screws to the concrete block floodwall. Caulking was applied to the joints, and sandbags were piled at the bottom on both the protected and the river sides. The closure was 56 inches high. Plastic sheeting was placed over the closure on the river side. The 8-foot-wide closure was constructed similarly, with the exception that it was made of double 1-inch-thick plywood with bracing on the protected side consisting of 2-inch by 4-inch lumber placed horizontally and vertically at the center of the closure with a diagonal 4-inch by 4-inch brace from the center of the wall to the concrete floor. A sump pump was present near the 8-foot-wide closure. The 1997 flood was up about 40 inches on the floodwall. The owner/resident waged a flood fight during the flood.

Lesson. This flood proofing system failed, inundating the structure up to the level of the flood. Failure occurred for basically two reasons. Excessive water seepage occurred at the 8-foot-wide closure due to inadequate sealing on the bottom and sides of the closure. To prevent this seepage, this closure, because of its width, should have been constructed of more rigid material such as aluminum with manufactured sealing membranes that would have increased sealing capability with increased hydrostatic force. This large closure was very critical and needed a “state-of-the-art” closure. The excessive seepage exceeded the capacity of the sump pump, causing water to accumulate on the concrete floor. This sump pump was powered by an electrical cord lying on the floor. The seepage water covered the cord, causing a “short” to occur and stopping the sump pump. Before power could be restored, seepage water continued to accumulate and flowed about 40 feet along the wall to a location where excavation had occurred for utility work sometime prior to the flood. The excavated area had not been properly compacted. The wetting of the poorly compacted excavated area and the hydrostatic force of water 40 inches high on the wall created “piping” that caused massive failure under the wall. The owner/resident was fighting the flood at the time of failure. In this case, he was able to escape because the fourth side of the protection was the “mainline” levee that provided a nearby safe evacuation route. If the floodwall had surrounded the structure and floodwater had surrounded the floodwall, no safe excavation route would have been available. This is a large concern when employing flood proofing measures such as levees, walls, or dry flood proofing where sump

Looking along a portion of the floodwall. The failure under the wall occurred in the immediate foreground. Note the largest closure at the right of the structure. Also note the Sacramento River in the background.

pumps are needed to evacuate seepage water and rainfall and owners tend to remain onsite to flood fight. For safety reasons, flood proofed structures should always be evacuated prior to being surrounded by floodwater. To do this, a fail-safe sump pump system needs to be employed--one that has redundancy so if one system fails another will come “online” automatically with or without electrical power. Another alternative is to manually switch the power source for the sump pump from an electric powerline source to either battery or generator, depending on the anticipated length of flood.

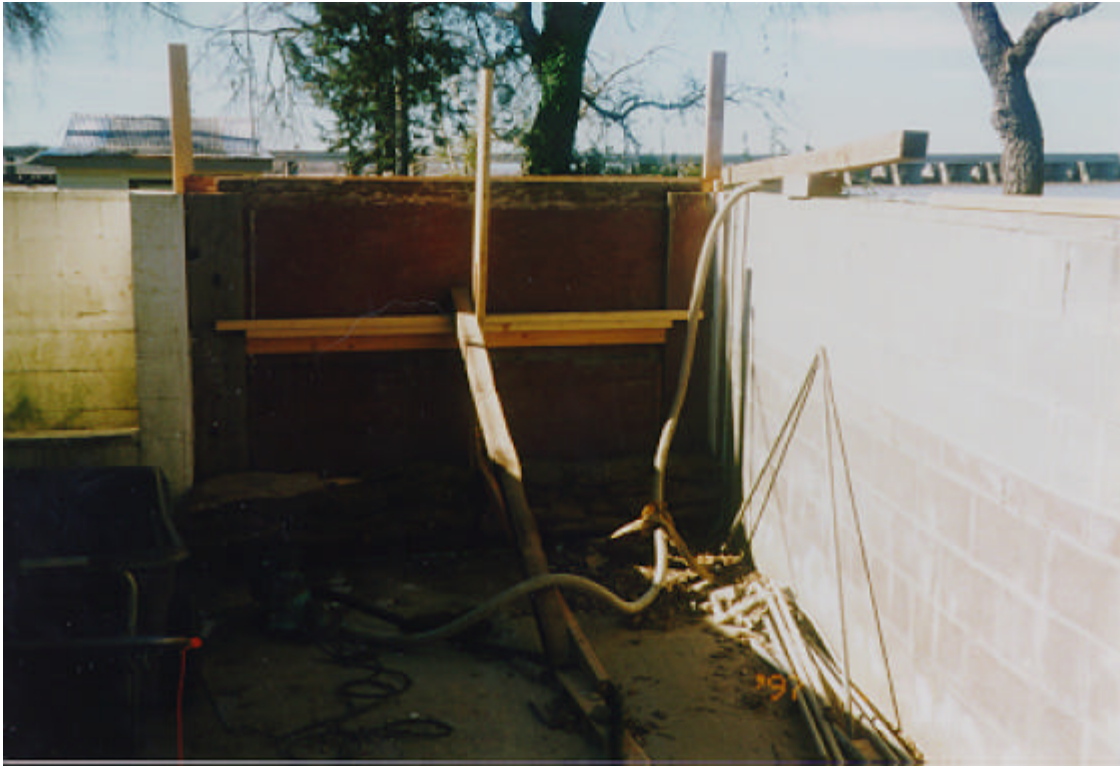
Looking at the largest closure structure and sump pump. Note the electrical cords on the concrete floor.

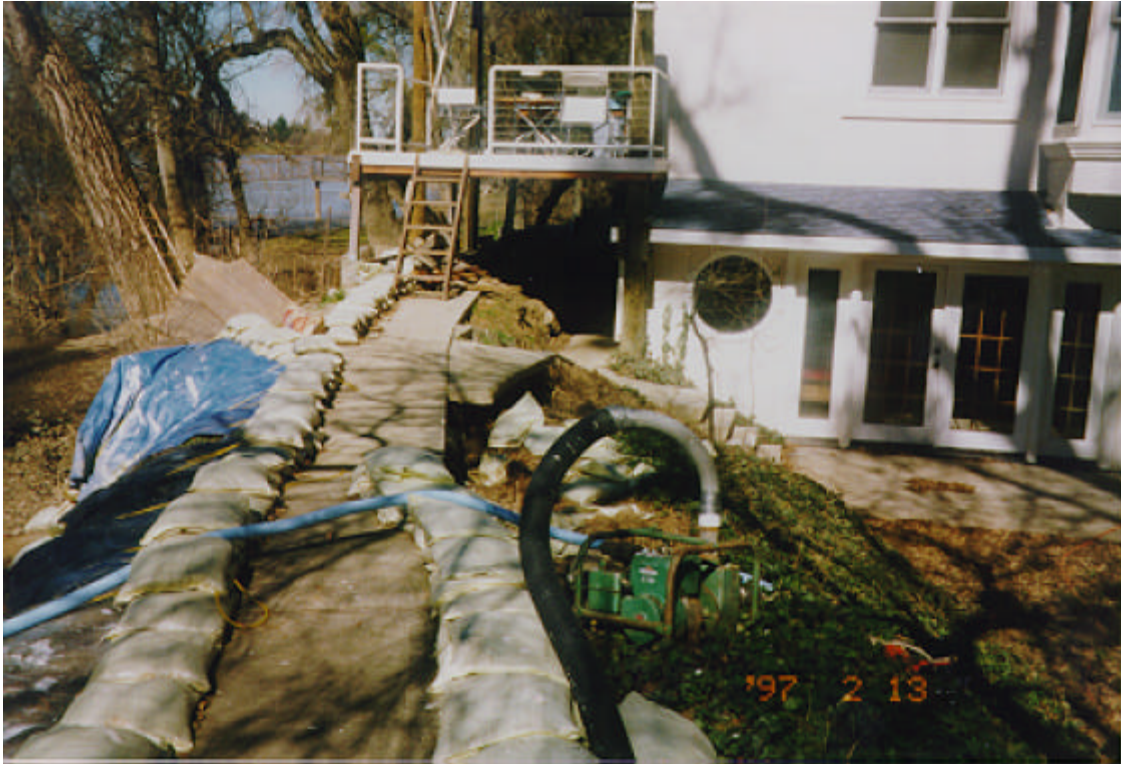
Lesson. The flood proofing measure failed due to overtopping of the levee. Sandbags had been placed on top of the levee but were not able to prevent overtopping and erosion of the protected side of the levee as water flowed over the top. More levee erosion would have occurred, leading to levee breaching, if the protected area had not been so small, allowing for rapid equalization of the water surfaces on both the protected and unprotected sides of the levee. Obviously, this levee was not high enough since it was overtopped in 1997 and also in 1986. The real lesson to be learned at this structure and also at Structure 90 is the choice of flood proofing measure. In these cases, the site location on a narrow strip of land between a major river and a “mainline” levee should be strongly considered when selecting a flood proofing measure. The ultimate flood proofing measure is relocation.

Looking along the overtopped levee. Note the Sacramento River at the left and the low elevation of the developed first floor of the structure relative to the river elevation.

Elevation or wet flood proofing, with the protected level no lower than 1 foot above the top of the mainline levee, would be the next choice. Barriers such as levees, walls, or dry flood proofing are not a good choice in locations such as the locations of Structures 90 and 91 because of the large height required for these measures to achieve protection to at least 1 foot above the top of the adjacent “mainline” levee.

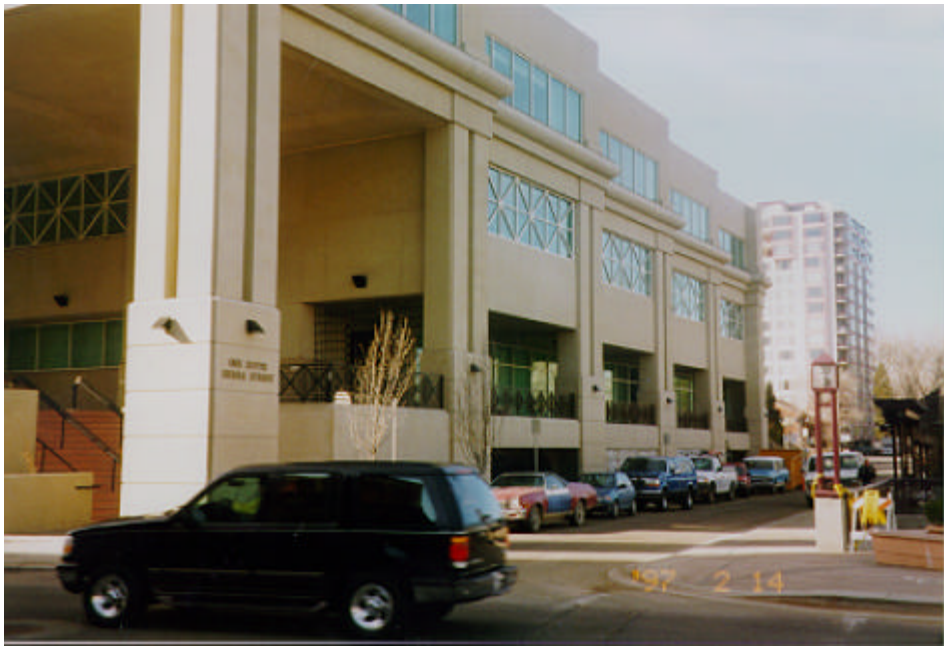
Lesson. The wet flood proofing measure functioned properly, with apparently little damage in this part of the lower level. The dry flood proofing measure however, failed. This measure was designed for 1 foot above the 100-year flood. The flood event of January 1997 exceeded that level. Floodwater overtopped the closure panel completely, inundating the protected area. Obviously, the closure panels and the reinforced concrete walls should have been designed for a higher level of flooding that would have completely closed all openings. The state-of-the-art metal panels with a pneumatic seal functioned as designed without damage. They were simply not high enough. In addition, it was reported that floodwater was already about 1 foot deep in the protected area before floodwater overtopped the closure panels, indicating water was leaking through the waterproofed reinforced concrete. The most reliable waterproofing method for reinforced concrete is to “sandwich” a nonpermeable membrane between the layers of concrete. No damage was apparent to the actual reinforced concrete wall due to hydrostatic force.

Looking at the structure. The Truckee River is immediately to the right.
The flood proofed floor is at the automobile level.

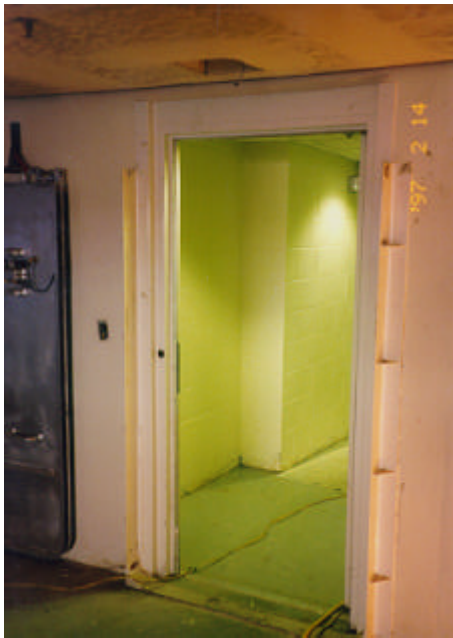
Looking at a doorway into the “protected” area. Note the state-of-the-art pneumatic seal closure at the left in its storage position. Also note the gap between the top of the closure and the top of the doorway.

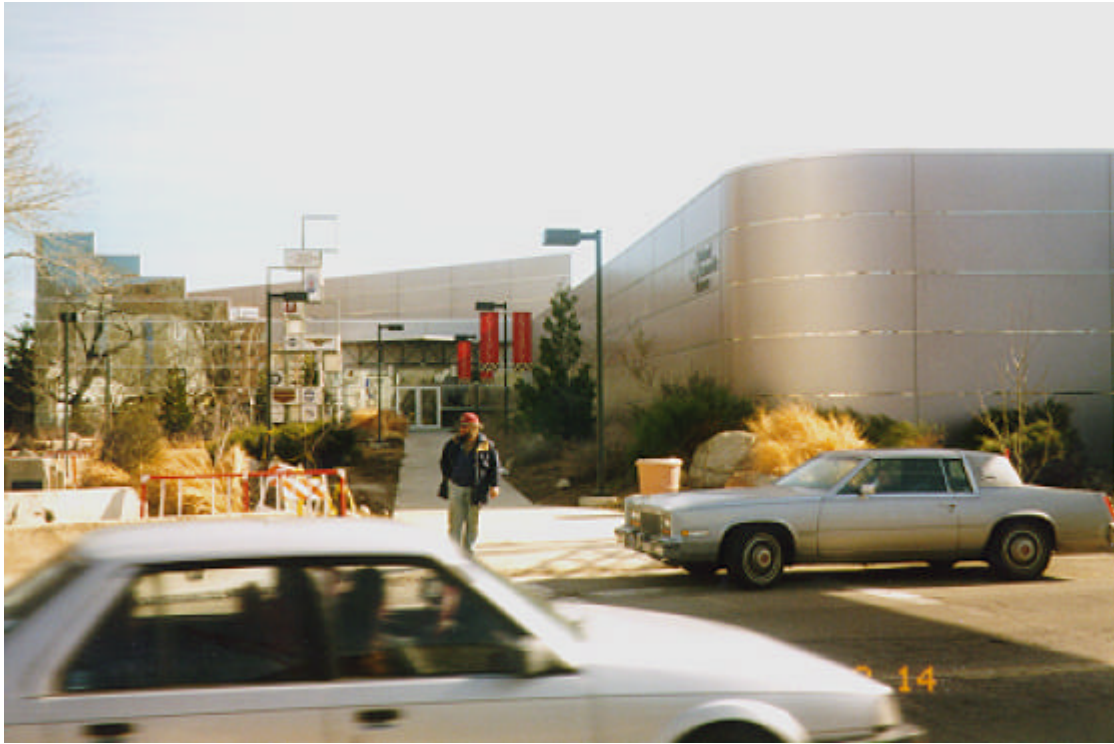
Lesson. This structure and its contents had minimal damage due to the flood proofing measure of elevation on fill and the flood fight. The lesson for this structure consists of four parts. First, the flood proofing measure enabled a flood fight to be successful. Second, a decision had to be made based on upstream flood information that a successful flood fight was possible while still keeping safety in mind for the flood fight personnel (since a basic parameter of flood proofing is to evacuate). Third, the impact of debris in the upstream bridge needed to be considered. This was evidently overlooked when the flood proofing elevation was selected. In the flood event, the upstream side of the bridge filled with debris to the extent that floodwater was forced out of the channel and onto the street just upstream from the structure at an elevation higher than the computed water surface elevation for a flood of this magnitude without the obstructive effect of the bridge. The fourth part of the lesson concerns the value of the contents in the structure. The contents consisted of \$25 million worth of nonreplaceable antique automobiles. Contents that are nonreplaceable should always be located in a flood-free location.

Looking from the upstream street downstream at the structure.
The doors in the background are one of the flood fight locations.

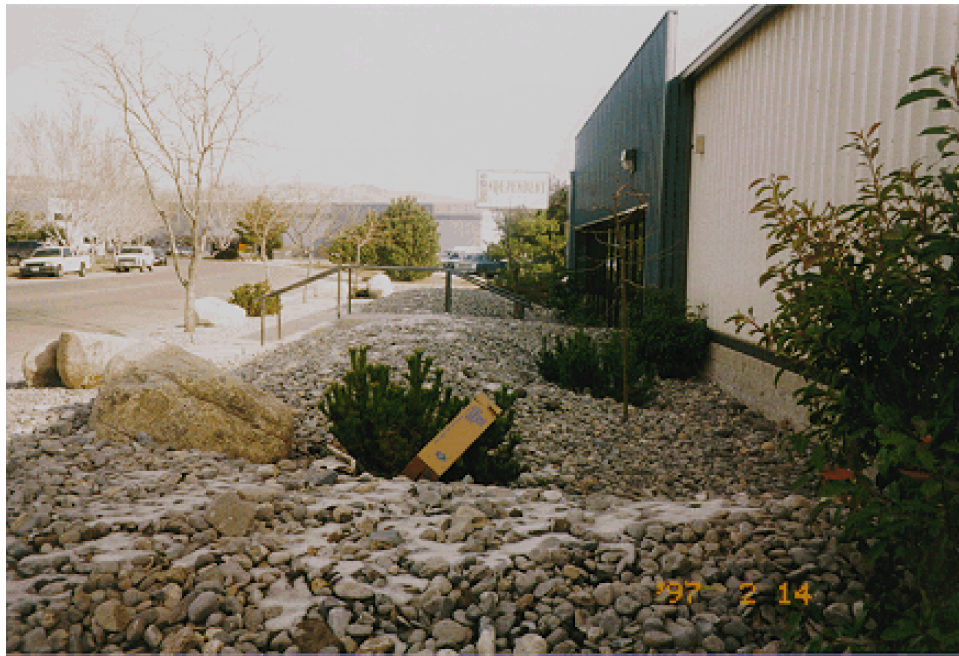
Lesson. These flood proofing measures were successful. Earthen embankments, especially in shallow-depth flood areas of short duration, can be quite effective if placed on a permanent or temporary basis. Obviously, all parts of an earthen embankment flood proofing measure such as interior drainage, closures, and so forth must be present and functional.

Looking along the earthen embankment with Structure 94 on the right. Note the raised handrail as the pedestrian entry to the building passes over the embankment.

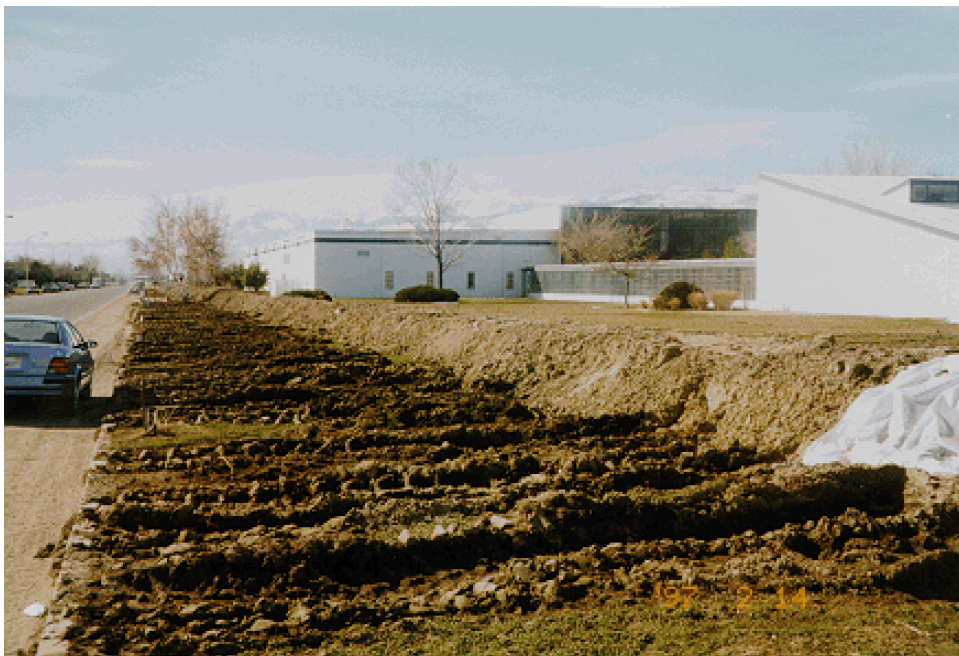
Looking at the recently constructed earthen embankment protecting Structure 95. Note the plastic sheeting at the far right that was placed over the embankment's unprotected side and held in place with sandbags to provide impermeability to the embankment.

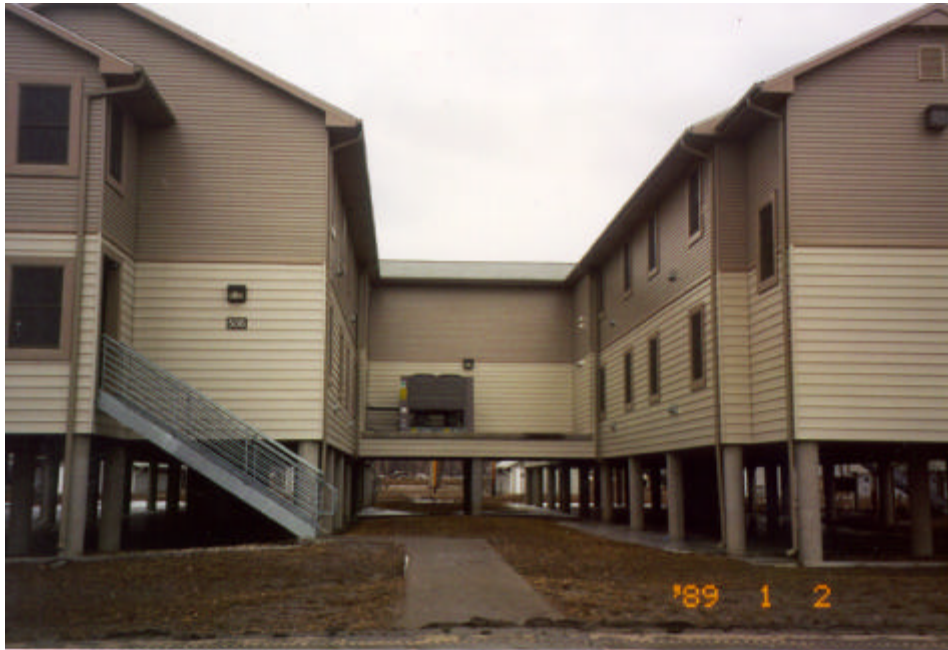
During the 1997 flood event, about 3 feet of floodwater inundated the area beneath the elevated buildings. Massive ice blocks also floated beneath the elevated buildings, directly impinging upon the posts. Floodflow velocity was moderate. No damage occurred due to either floodwater or the impact of the ice blocks.

Lesson. This flood proofing system performed very well in this flood event. The buildings were elevated enough to be above the flood elevation and the posts were strong enough to withstand the impact of floating ice blocks without damage. Erosion was not a factor for the event.

Looking at one of the elevated buildings.

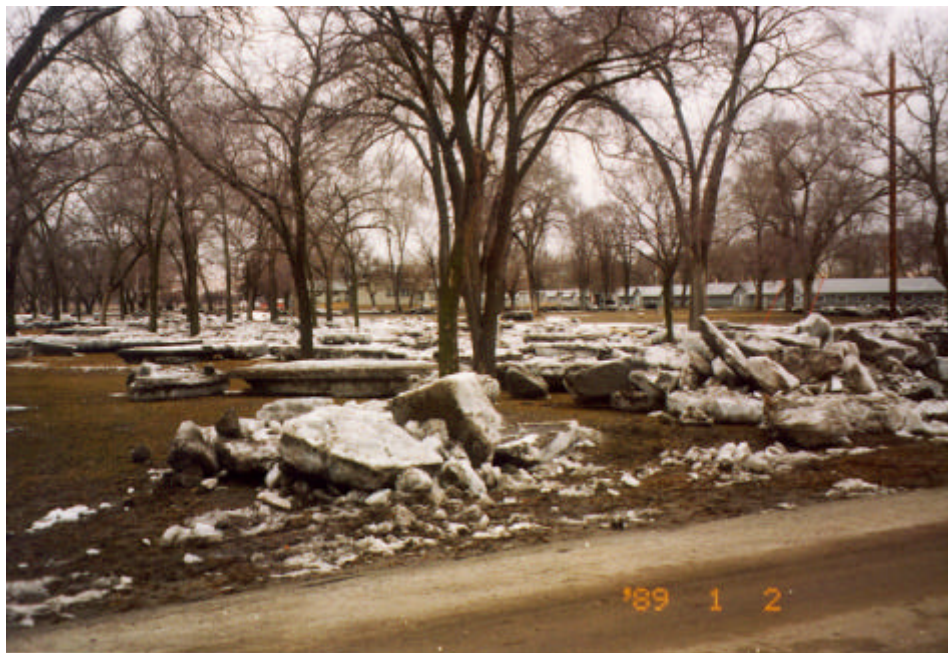
Looking at the massive ice blocks that passed through the area.

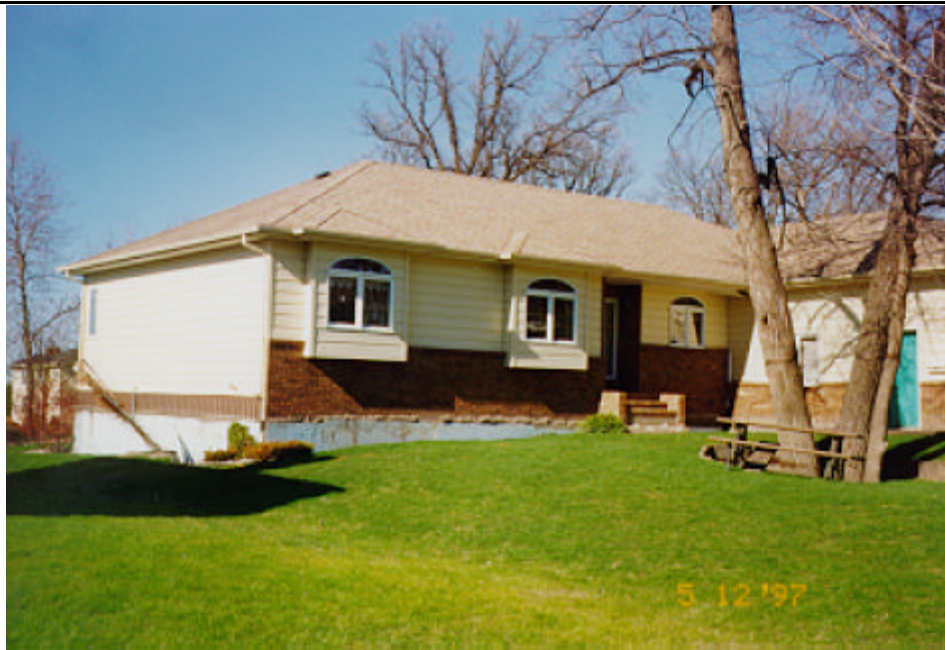
STRUCTURE 97. This structure was a one-story, single-family residential building with a basement. It had an attached double car garage on its east side. It was constructed about 1990. The structure was wood-frame construction resting on foundation walls of reinforced poured concrete. The soil surrounding the structure was a mixture of silt and clay. The structure was about 350 yards from the Red River and was protected by a “mainline” levee located close to the river channel bank. The structure was dry flood proofed. The basement floor and walls were constructed of 8-inch-thick concrete with $\frac{1}{2}$ inch rebar located horizontally and vertically every 6 inches. A nonpermeable neoprene membrane was located in the middle of the 8-inch-thick walls and floor. The structure did not have a sump pump. Velocity was not a factor. The first floor was about 3 feet above ground and about 2 feet above the 100-year flood.

Lesson. This structure was dry flood proofed at a far greater expense than conventional construction of adjacent foundation walls and floors in the neighborhood that were not flood proofed. Only one mistake was made, but it proved to be very costly. The effects of hydrostatic force were considered structurally in the strength of the walls and floor of the basement but not in the ability of the structure to resist uplift force (buoyancy). The designer of this flood proofing system specified that in order for the structure to resist buoyancy, the structure owner needed to fill the basement with a minimum of 42 inches of water. The structure owner chose not to do this. Upon failure of the mainline levee, floodwater surrounded the dry flood proofed portion of the structure and entered the garage, which had a floor at grade. The flood peak was 20 inches deep on the garage floor but was still below the design level of the dry flood proofing measure. However, within 12 hours of floodwater surrounding the structure, the hydrostatic force lifted the west edge of the structure as much as 4½ feet. The eastern edge of the dry flood proofed part of the structure was held in place by the attached garage. Damage to the structure resulted from the unequal lifting of the structure (structural damage) and rupture of the utility lines that entered the basement (floodwater entry). Signs of an electrical fire in the outside panel box were evident, probably as the electrically charged underground lines were pulled from the panel box as the structure lifted. The irony of this example is that the structure that was dry proofed was considered severely damaged while adjacent structures that were not flood proofed only incurred damage due to water in basements but were structurally sound and could be reoccupied. This example points out the difficulty of dry flood proofing a structure with a basement because of the effects of hydrostatic force. In this case, at least five items should have been done further to help offset the effects of hydrostatic force while not purposely placing water in the basement. One, the soil around the basement wall should have been properly compacted to make the

Looking at the structure. Note the garage on the right that held that part of the structure down and the exposed basement wall on the left indicating the amount of lifting that occurred on the west side.

soil as impermeable as possible. Two, a drain field should have been installed around and beneath the basement floor leading to a sump pump to reduce hydrostatic force buildup by evacuating water. Three, the design should have incorporated measures to ensure that the floodwater never touched the basement wall. Four, as part of the floor, a structural anti-buoyancy device consisting of basically a floor slab extending beyond the walls but tied to the floor with rebar so the weight of the soil would act to offset the hydrostatic force against the basement floor should have been installed. Five, “blowout plugs” should have been installed in the floor. These plugs are designed to withstand hydrostatic force but will “blow out” prior to hydrostatic force making the structure buoyant. Soil permeability is obviously very critical. In this example, a silt clay soil should have been able to resist saturation longer than 12 hours. Improper backfill material type and compaction adjacent to the structure may have been major components leading to such rapid saturation of this soil type. In this specific case, since the owner knew that items two through five were not part of the design, the basement should have been purposely flooded with at least 42 inches of water prior to evacuating the structure. This was done to a similarly flood proofed structure in the area and only minor water damage occurred to the unfinished basement.
